M6 Toll, Dunton Lane

Freyssinet Ltd

**16m³ with 120m³
surface prep**

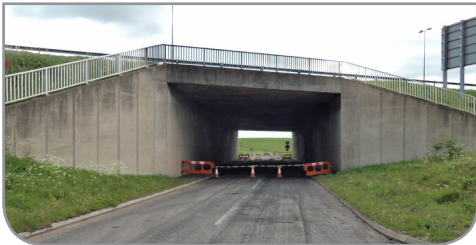
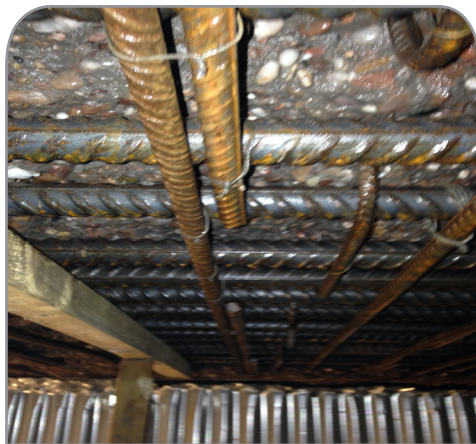
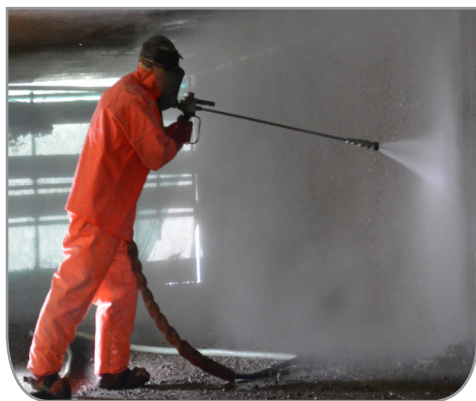
A lorry fire under the M6 Toll at the Dunton Lane underbridge resulted in significant structural damage. The M6 Toll engineering team invited the main contractor Freyssinet Limited to attend site in order to assist with the assessment of the damage and work with the design team to produce a suitable repair strategy.

Aquaforce was mobilised quickly as part of this team to provide information and advice regarding the works required, which included hydrodemolition to the soffit and the walls.

Aquaforce team operated from adapted scaffold access which allowed hydrodem to be undertaken on the east side of the structure, while spray concrete was being undertaken concurrently on the west side. This made significant time savings to the overall scheme and ensured that the M6 Toll was re-opened on schedule.
